**Flood Control Project Maintenance  
Levee Inspections**

## Maintenance Issue Types Only, Levee Inspection Report By Mile - Spring 2019

### Sacramento Maintenance Yard East Levee Yolo Bypass

Waterway	Bank	Unit Miles	Inspection Start/End	Inspector
Unit No. 01 Yolo Bypass	Left	2.01	03/05/2019 03/05/2019	Zach Jojola

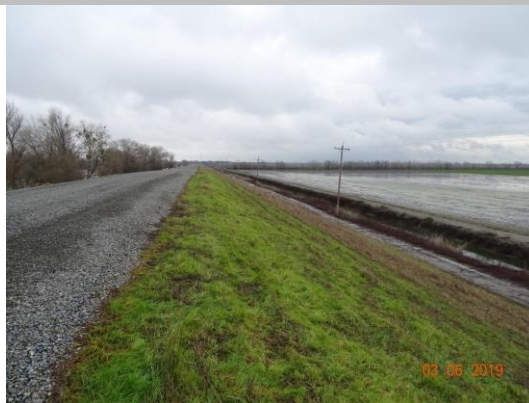
Photo 1 of 1 : SP\_2019\_ST0004\_41\_8\_20190311\_00011.jpg

LM Start	1.51	Rating **	A	Issue No.	8
LM End	1.51	Issue Type +	Ma	Location *	LS
Category	Earthen Levee			GPS Latitude/Longitude	
				Start	End
Item	Vegetation			38.743589 °	38.743589 °
				-121.634173 °	-121.634173 °
DWR ID	DWR_ST0004_01_s_2019_8				
Comment Code					
V1 : Control annual grass and weeds on the levee slopes and easements.					
Inspector Comment					
LMA maintains vegetation at an acceptable level.

View of well-maintained vegetation on the landside slope. Spring 2019.

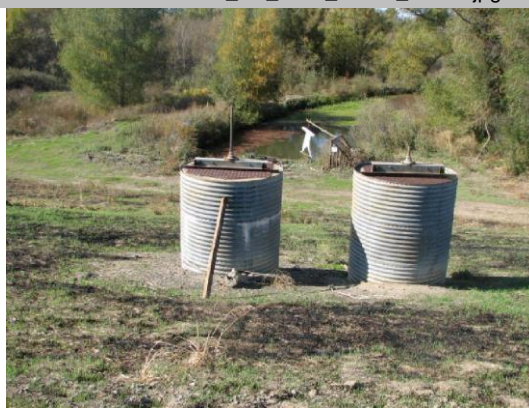
Photo 1 of 3 : UCIP\_SP\_2019\_53253\_60261.jpg

Comment Code						
Inspector Comment						
FS_ID:53253 DS_ID:838 EP_NO: N/A Repair Type: No Action Needed Crossing Status: Found UCIP Comments: 11/16/17 Ted Skidgel, pipe is closed on w/s and closed on L/S. Mud removed recently from WS pipes. FIELD_STRUCT_DESC: 1 of 2: 48-inch corrugated metal drainage pipe through the levee, 28.5 feet below the crown. 30-inch steel pipe sleeved through the 48-inch pipe. Slide gate in a 60-inch pipe riser on the waterside (WS) slope. [Additional Reference(s): DWR Levee Log, 1981. USACE Sacramento O&M Manual 123, August 1955, (Station 382+85)]. No permit or as-built drawing available. FS Date: 11/21/2018 8:31:59 AM

Waterside view: overview CMP standpipe and water body

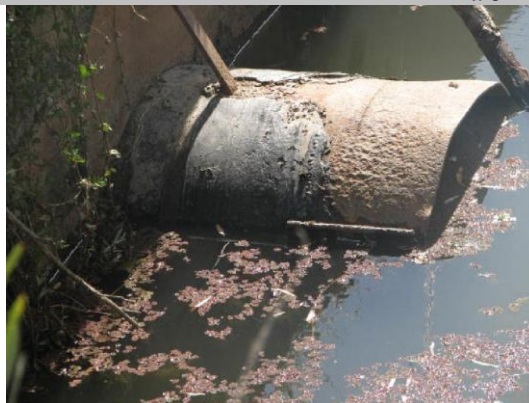
Photo 2 of 3 : UCIP\_SP\_2019\_53253\_60260.jpg

Waterside view: steel pipe and concrete headwall

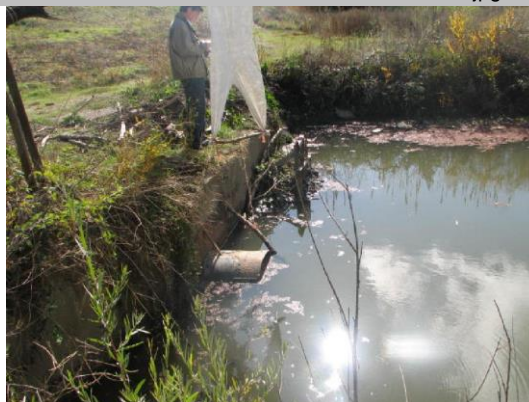
Photo 3 of 3 : UCIP\_SP\_2019\_53253\_60259.jpg

Waterside view: overview steel pipes and concrete headwall

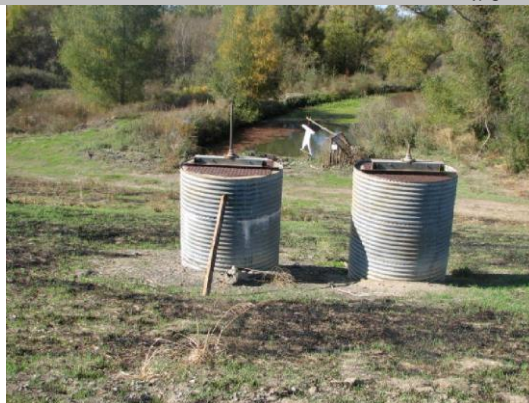
Photo 1 of 3 : UCIP\_SP\_2019\_53254\_60269.jpg

LM Start	1.71	Rating **	A/W	Issue No.	10
LM End	1.71	Issue Type +	Ma	Location *	
Category	Supplemental			GPS Latitude/Longitude	
				Start	End
Item	DWR UCIP LMA Responsibility			38.740686 °	38.740686 °
				-121.633979 °	-121.633979 °
DWR ID	840				
Comment Code					
Inspector Comment					
FS_ID:53254 DS_ID:840 EP_NO: N/A Repair Type: No Action Needed Crossing Status: Found UCIP Comments: FIELD_STRUCT_DESC: 2 of 2: 48-inch corrugated metal drainage pipe through the levee, 28.5 feet below the crown. 30-inch steel pipe sleeved through the 48-inch pipe. Slide gate in a 60-inch pipe riser on the waterside (WS) slope. [Additional Reference(s): DWR Levee Log, 1981. USACE Sacramento O&M Manual 123, August 1955, (Station 382+85)]. No permit or as-built drawing available. FS Date: 11/21/2018 8:34:20 AM

Waterside view: overview of CMP standpipe and water body

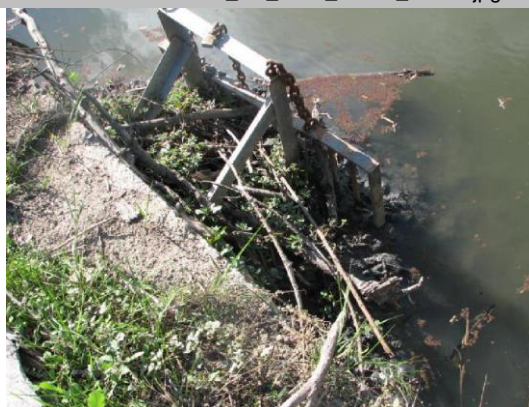
Photo 2 of 3 : UCIP\_SP\_2019\_53254\_60268.jpg

Waterside view: mud clogged pipe, trash rack and headwall

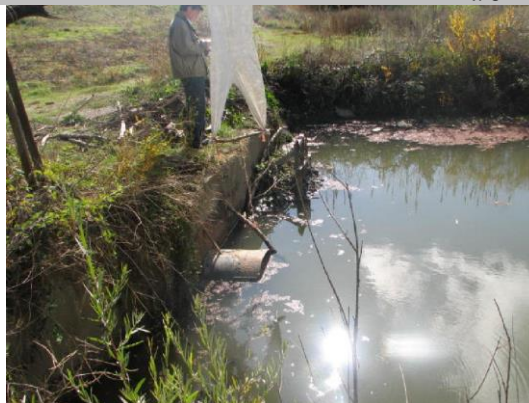
Photo 3 of 3 : UCIP\_SP\_2019\_53254\_60267.jpg

Waterside view: overview pipes and headwall
